Manhole Inspection Summary

Manhole # S21K__041MH

Insp Date: **9/26/07 11:11 AM**

Location Address: **1824 ADDISON ST**

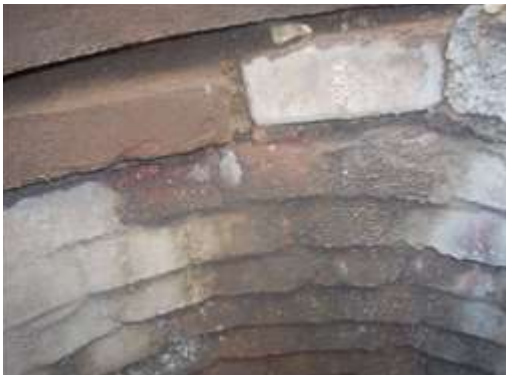
Defect 3

Infiltration: ☐ None ☒ **Joint** ☐ Cracks ☐ Mortar ☐ Roots ☐ Wall

INFILTRATION OF THE CORBEL JOINT

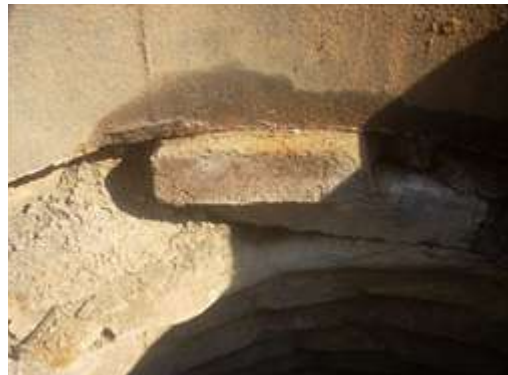
Defect 2

Condition: ☐ Sound ☐ Cracked ☐ Root Intrusion ☒ **Loose Brick** ☒ **Deteriorated**

DETERIORATED CHIMNEY WITH LOOSE BRICKS

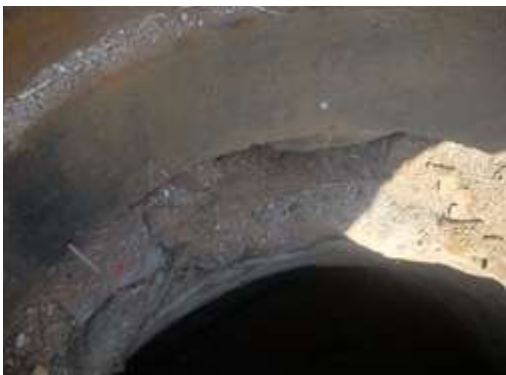
Defect 1

Offset: **3** (in.)

FRAME OFFSET

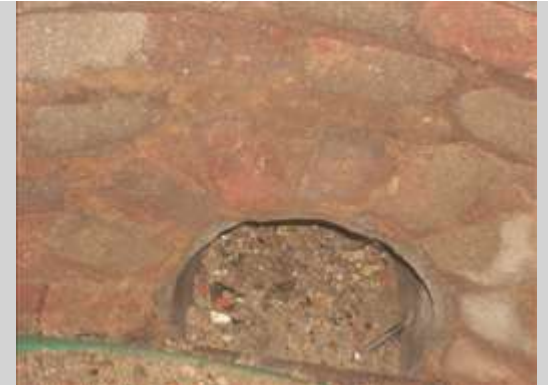
12 O'Clock Outflow

8 in. Circular Gravity Sewer
Pipe Out @ 12 O'Clock

Deposits: ☐ None ☐ Mud ☐ Sludge ☒ **Debris** ☐ Grease

Silt Depth: **1** (in.) Deposits Extent: **Light**
